# Home Inspection Report

Inspection Date:  
**01/01/2016**

Report Number:  
**20160211**

Inspection Address:  
**1234 Cheery Lane**  
**Fremont, CA**

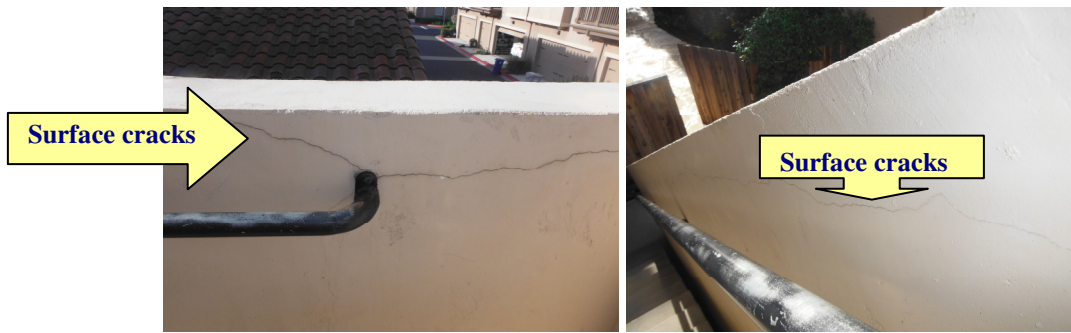
*One or more sections of the rear staircase (top railing) wall were noted with surface cracks. We recommend sealing all surface cracks. Doing so will help prevent moisture intrusion within the cavity of the wall. .*

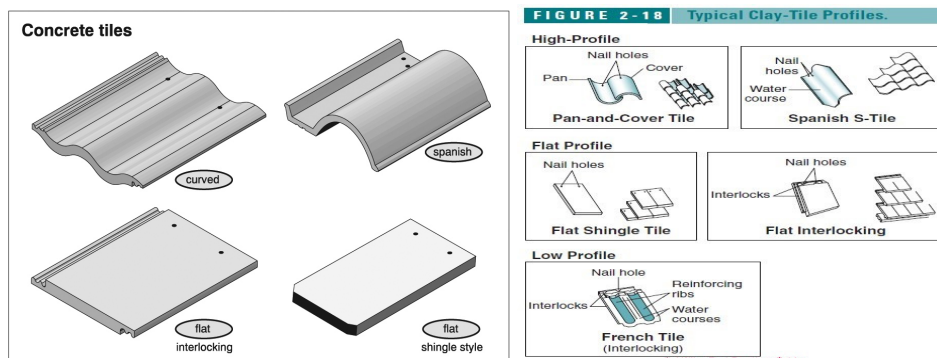
*Several of the roof tiles located toward the front of the dwelling appears to have been replaced several tiles.*

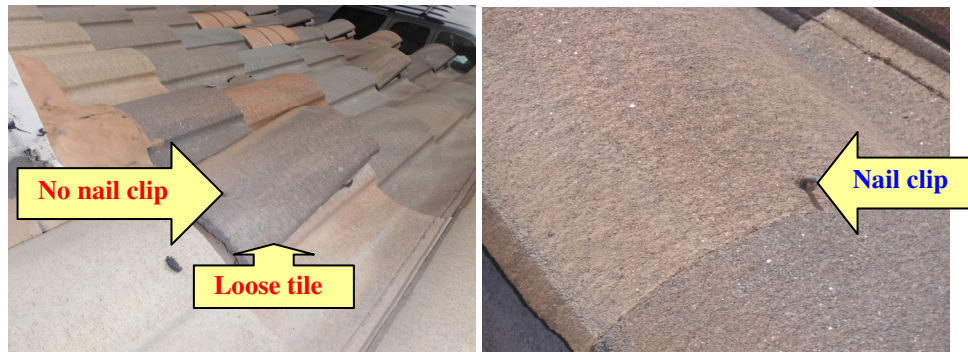
One roof tile located in the front of the dwelling was not properly secure. The nail clip was missing, which can allow the tile to fall off during a windy day. We recommend the advice of a licensed Roofing professional, followed by corrective action as needed to improve its current condition.

**One roof tile located in the front of the dwelling was not properly secure. The nail clip was missing, which can allow the tile to fall off during a windy day.**

**We recommend the advice of a licensed Roofing professional, followed by corrective action as needed to improve its current condition.**

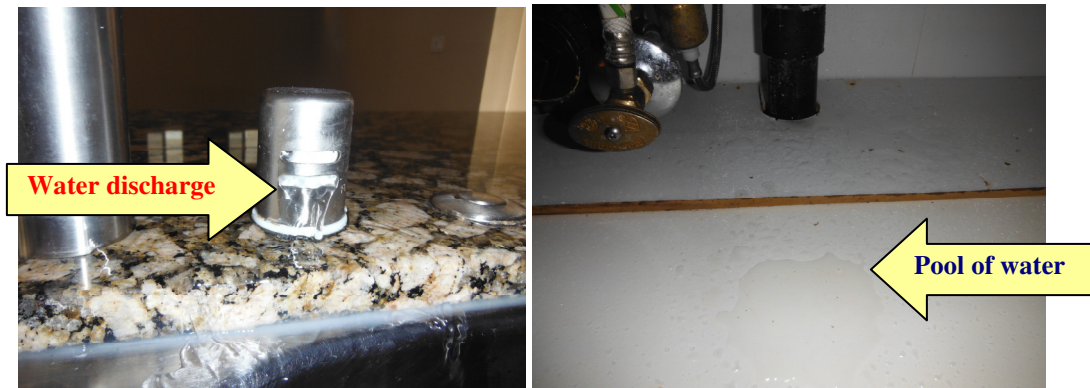
### **The Dishwasher Drain Separation**

The dishwasher drain was equipped with an air-gap fitting (the cylinder protruding above the sink). This device assures separation of the supply water from the wastewater. During the functionality of the dishwasher, water was discharging from the drain separation (air gap). The water was dripping underneath the base of the air-gap causing the water to drip into the cabinet.

**We recommend the advice of a licensed professional; followed by corrective action to improve its current condition.**

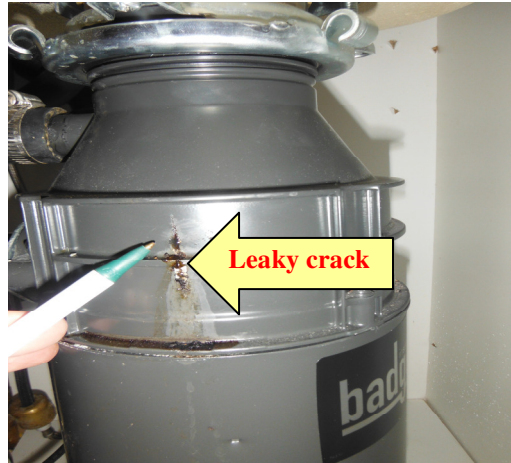
One section of the garbage disposal casting was noted with a surface crack which was leaking during our inspection. We recommend the advice of a licensed professional; followed by corrective action to improve its current condition.

**One section of the garbage disposal casting was noted with a surface crack which was leaking during our inspection.**

**We recommend the advice of a licensed professional; followed by corrective action to improve its current condition.**
